# Death in the line of duty...

A summary of a NIOSH fire fighter fatality investigation

January 21, 1999

## **Two Career Fire Fighters Electrocuted after the Aluminum Extension Ladder They Were Using Contacted a 7,620-volt Overhead Power line - Kansas**

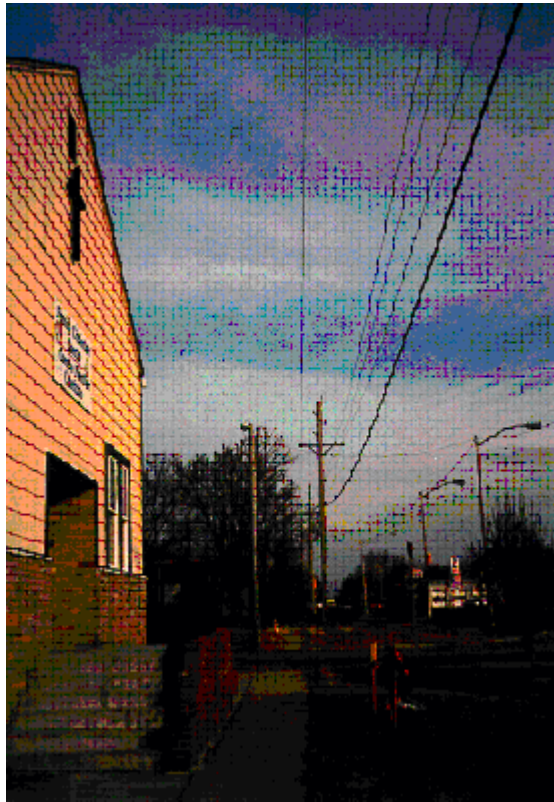
On November 24, 1998, the wife of the pastor of a local church telephoned City Hall and requested the use of an aerial ladder. The aerial ladder was to be used by a painting contractor to finish painting the upper section of the church (see Figure 1), which was about 30 feet from the ground and could not be reached from the ladders the painters were using.

about 35 feet and laid back against the side of the church. This time the ladder was extending over the peak of the church's roof and again was not in the correct position for use by the painters. A decision was made to reposition the ladder a third time by lifting and sliding the butt section a couple of feet and then pulling the ladder back to a vertical position before again positioning it against the side of the church. The Captain, who had been overseeing the operation, moved to the ladder and grasped a side rail to help steady it. The top of the ladder was resting against the side of the church, and its feet on the ground directly under a single phase of an overhead power line, which was 34 feet 3 inches from the ground. The crew then attempted to reposition the ladder. One fire fighter was grasping the halyard (rope), while the remaining three fire fighters and Captain steadied the ladder and pulled it back to a vertical position. As the ladder was being repositioned, the top of the ladder contacted the 7,620-volt overhead powerline (see Figure 2). Electrical current passed through the ladder, and through the fire fighters and Captain who were in contact with the ladder, to the ground. Three fire fighters and the Captain were knocked to the ground. The fire fighter who was holding the halyard was uninjured. The uninjured fire fighter ran to the engine and called 911 for assistance. The Police Department heard the call and dispatched personnel who arrived on the scene within 2 minutes. The police personnel, along with the uninjured fire fighter and a slightly injured firefighter, checked for vital signs and provided CPR to the Captain and one fire fighter, who were in cardiopulmonary arrest. An ambulance arrived shortly thereafter and paramedics continued CPR while transporting the injured to the hospital. About 1 hour later the Captain and one fire fighter were pronounced dead, one fire fighter was hospitalized in serious condition, and the other fire fighter was treated and released. The fire fighter hospitalized in serious condition was subsequently discharged from the hospital.

*Figure 1. Incident Scene where ladder contacted overhead power line.*

Discussion: Since fire departments often provide important community services, fire fighter safety should be addressed and incorporated into all work projects, whether they involve fire-related projects or community services, during both the planning and operational phases of the work projects. The planning phase should identify all hazards that may be encountered and the procedures and safety interventions to be implemented to control or eliminate such hazards. These procedures should include, but not be limited to, inspecting the work environment before initiating work, developing safe work practices and procedures, providing training in hazard recognition and abatement, and identifying and addressing personal protective equipment (PPE) needs where applicable. In this case an assessment of the work project was completed. However, the overhead power line hazard was not recognized as a hazard and therefore was not abated or controlled. When work must be done in proximity to energized power lines, the local utility company should be contacted who can either de-energize, if practicable, or cover the power lines with insulating line hoses or blankets.

Discussion: In some cases the use of conductive ladders may be unavoidable, but when work projects are not of an emergency nature, fire departments should consider eliminating the use of conductive ladders (aluminum) in proximity to energized electrical conductors (powerlines). Although all fire departments are not subject to Occupational Safety and Health Administration (OSHA) Standards, OSHA Standard 29 CFR 1926.1053(b)(2) states that "portable metal ladders shall not be used for electrical work or where they may contact electrical conductors." Ladders made of non-conductive materials, e.g., fiberglass, should be used for work near energized conductors.

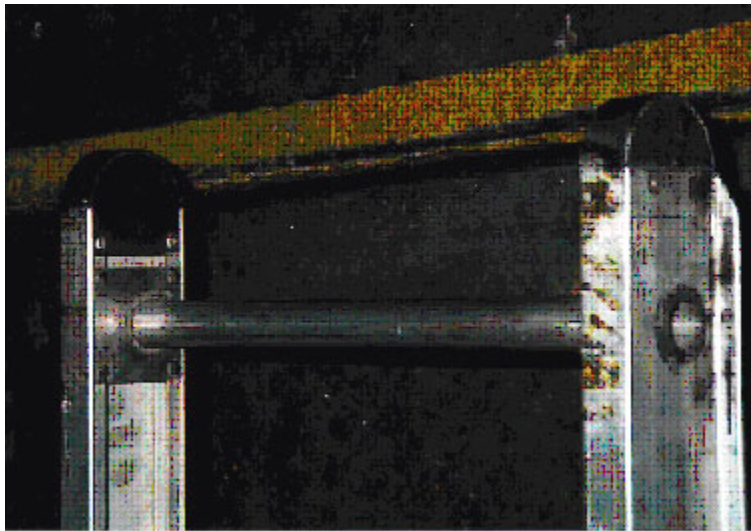
*Figure 2. Top section of ladder with burn marks.*

Discussion: The use of nonconductive materials in the manufacture of aluminum ladders could provide passive protection to all affected workers in the event of an inadvertent contact with an electrical conductor. One possibility to consider is the placement of a fiberglass link in the side rails of new aluminum ladders. This link would provide isolation so electricity does not have a path to ground. Additionally, incident data from the U.S. Consumer Product Safety Commission suggest that approximately 42% of ladder contact with powerlines occurs within the top 3 feet of the ladder.<sup>2</sup> Therefore, consideration should be given to insulating the ladder's top few feet with a material that is non-conductive (e.g., heavy Teflon).
